Biglis Active Travel Bridge

Geotechnical Desk Study

Report Reference: 10058585-ARC-XXX-XX-TR-GE-00001-P01

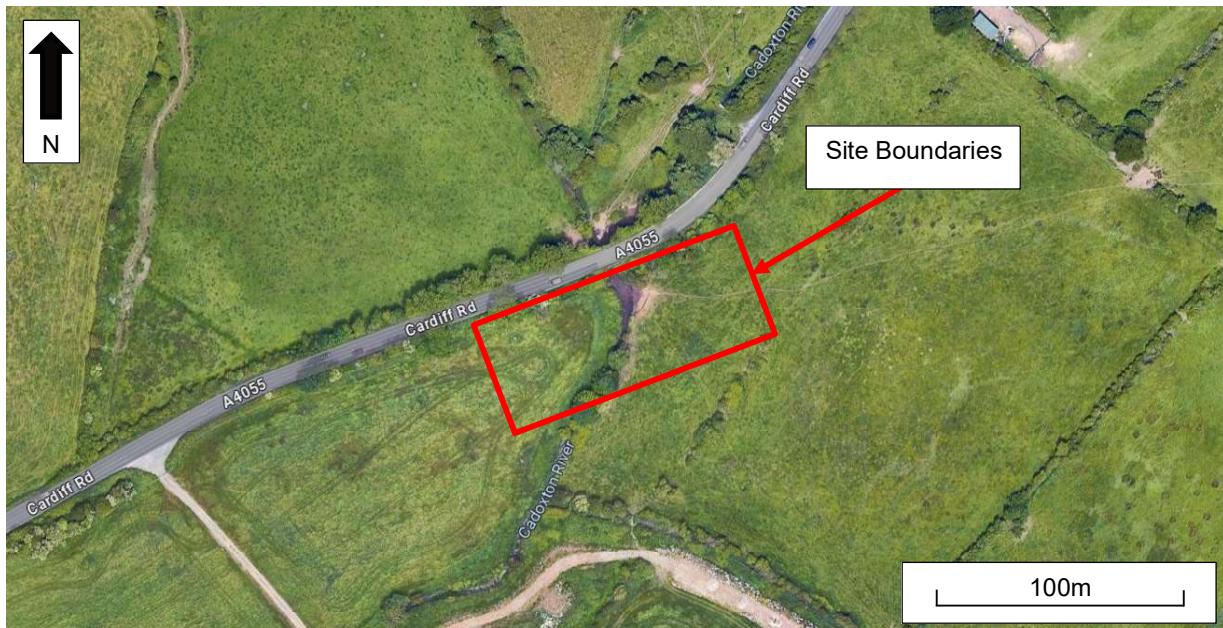
Figure 2-1: Site Boundaries

The Site is located approximately 300m east of Palmerstown, Barry, South Wales, UK. The nearest post code is CF63 2BA and the Site is centred at Ordnance Survey grid reference ST 14896 69301. Figure 2-1 shows the Site extents defined within the scope of this report.
